RESEARCH AND DEVELOPMENT TECHNICAL REPORT
CORADCOM- CONTRACT NUMBER DAAK80-79-C-0771

EXPLORATORY DEVELOPMENT MODEL HERMAPHRODITIC FIBER OPTIC CONNECTORS

J. F. Dalglish
H. H. Lukas
BELL-NORTHERN RESEARCH
OTTAWA, CANADA

FINAL REPORT

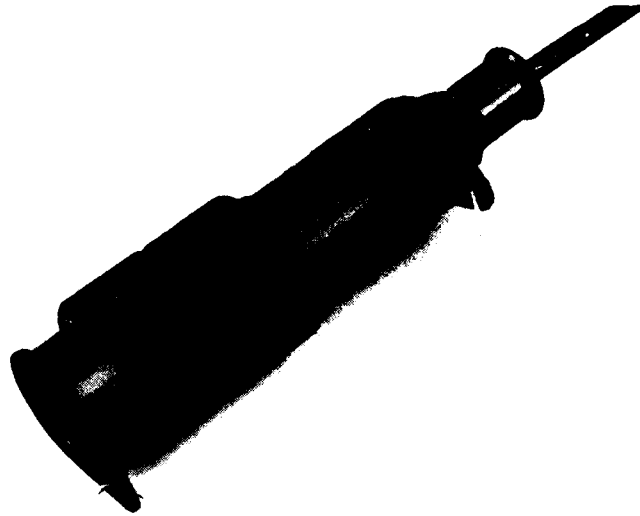
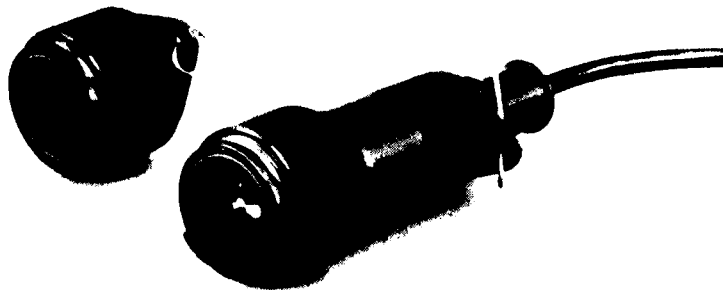
Figure 3.2 shows the installed connector plug;

- (a) with the protective cap in place.
- (b) with the protective cap removed.
- (c) mated in a plug-to-plug configuration.
- (d) with the mating interface removed to gain access to the fiber ends and alignment member for cleaning.

(a) PROTECTIVE CAP IN PLACE

(b) PROTECTIVE CAP REMOVED

(c) MATED: PLUG-TO-PLUG

(d) MATING INTERFACE REMOVED
FIGURE 3.2: CONNECTOR PLUG

The housings, mating interface, coupling nuts, cable strain relief and protective cap are made of black-anodized aluminum.

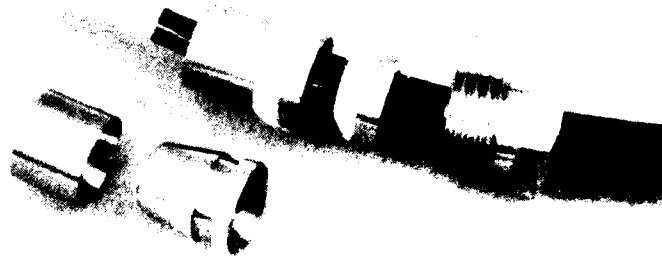
FIGURE 4.7: CABLE TERMINATION

- (d) The cable termination is completed, as illustrated in Figure 4.7. The internal sleeve is placed on the end of the outer sheath. The Kevlar strands are folded back over the tapered outer surface of the internal sleeve. The external sleeve is placed over the Kevlar strands, trapping them between the two sleeves, and the Kevlar strands are trimmed (12) to the end of the sleeve assembly. The fibers and cable termination

(a) PART IDENTIFICATION AND RELATIVE POSITIONS

(b) ACTUAL HARDWARE
